Delayed disaster

Earthquakes and tornadoes may be sudden, but at least they signal their arrival. However, that's not the case when business as usual obscures the onset of life-threatening conditions.

*By John F. Weaver
Research meteorologist
National Oceanic & Atmospheric
Administration, Fort Collins, Colo.*

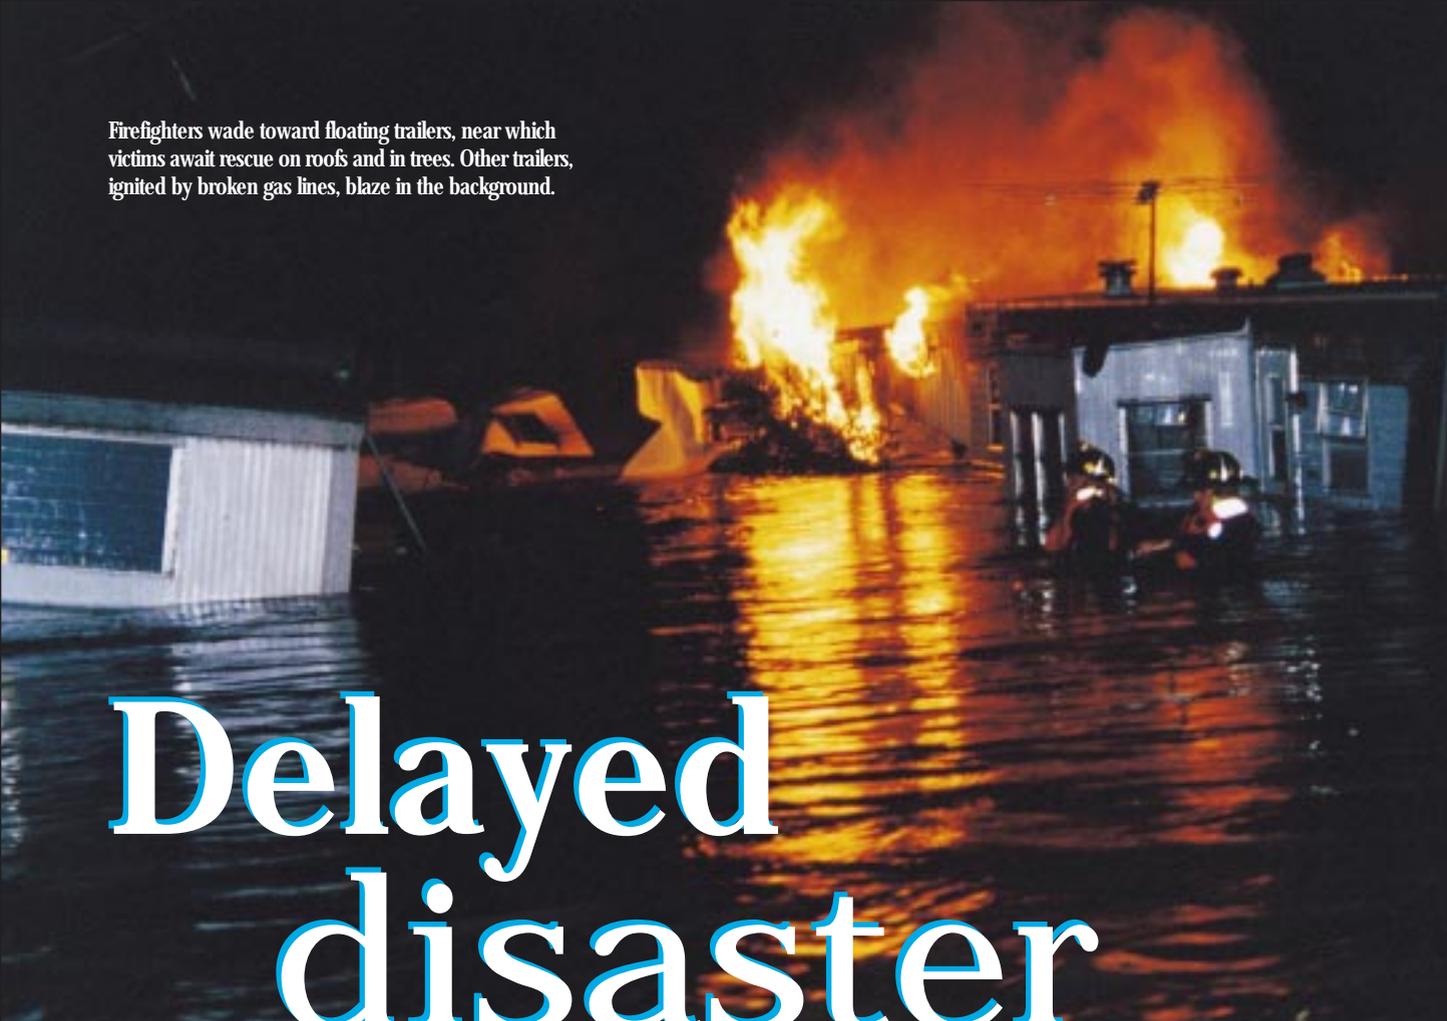
Firefighters wade toward floating trailers, near which victims await rescue on roofs and in trees. Other trailers, ignited by broken gas lines, blaze in the background.

The combined flow from the culvert and the overtopping surged into two trailer parks directly east of the tracks. Several witnesses who'd driven through the parks just 20 minutes earlier saw only rain-dampened roads. By 11 p.m., however, 8-foot-deep raging waters were floating trailers and sweeping victims into the 12-foot-deep Spring Creek channel. Broken gas lines had ignited three mobile homes, which burned fiercely in the middle of the flood

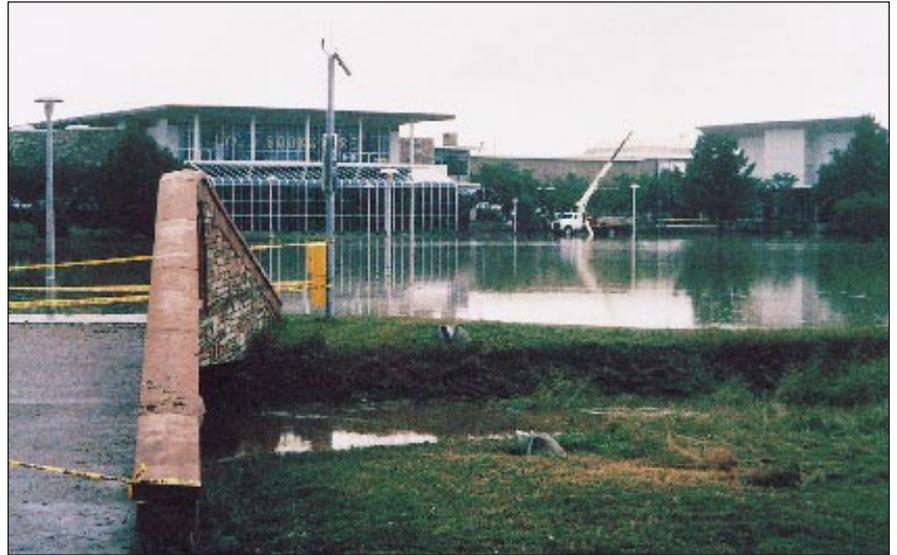
Water pours onto the campus of Colorado State University, where parked cars are caught as the flow increases. The next morning, the Lory Student Center sits in the middle of a lake.

The water washed onto the campus of Colorado State University, flooding the campus police and dispatch center, smashing through large picture windows in the Morgan Library, and inundating the massive student center complex. A man who'd been trying to squeegee trickles of water from the west entrance of the student center left just seconds before 4- to 5-foot-high water broke through the double glass doors.

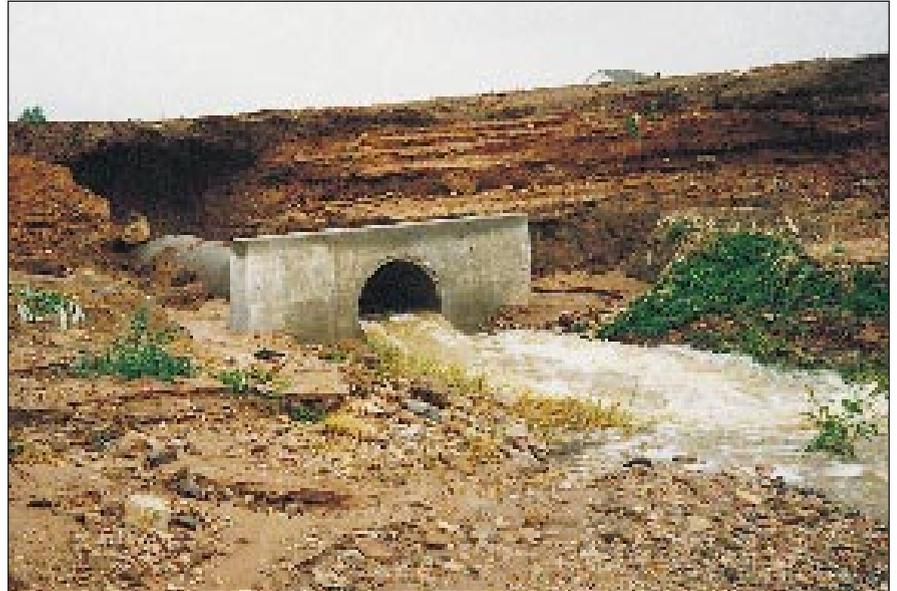
In the early morning hours of July 29, 1997, the devastation is obvious. Here, the east side of the Pleasant Valley and Lake Canal embankment has been scoured away by rushing overflow.

Down at the end of a small lowland cul-de-sac in a middle-class subdivision, the bank of the PV&L Canal overtopped and began to erode away. Runoff water that had previously been held back by the canal embankments now poured into houses, soon reaching as high as the first-floor ceilings. The engineer who'd gone down to check on the canal was caught by this event, and nearly drowned before grabbing onto a passing tree.
